**WASHINGTON DULLES INTERNATIONAL AIRPORT**

**VPDES PERMIT VA 0089541**

**2012-2013 ANNUAL REPORT**

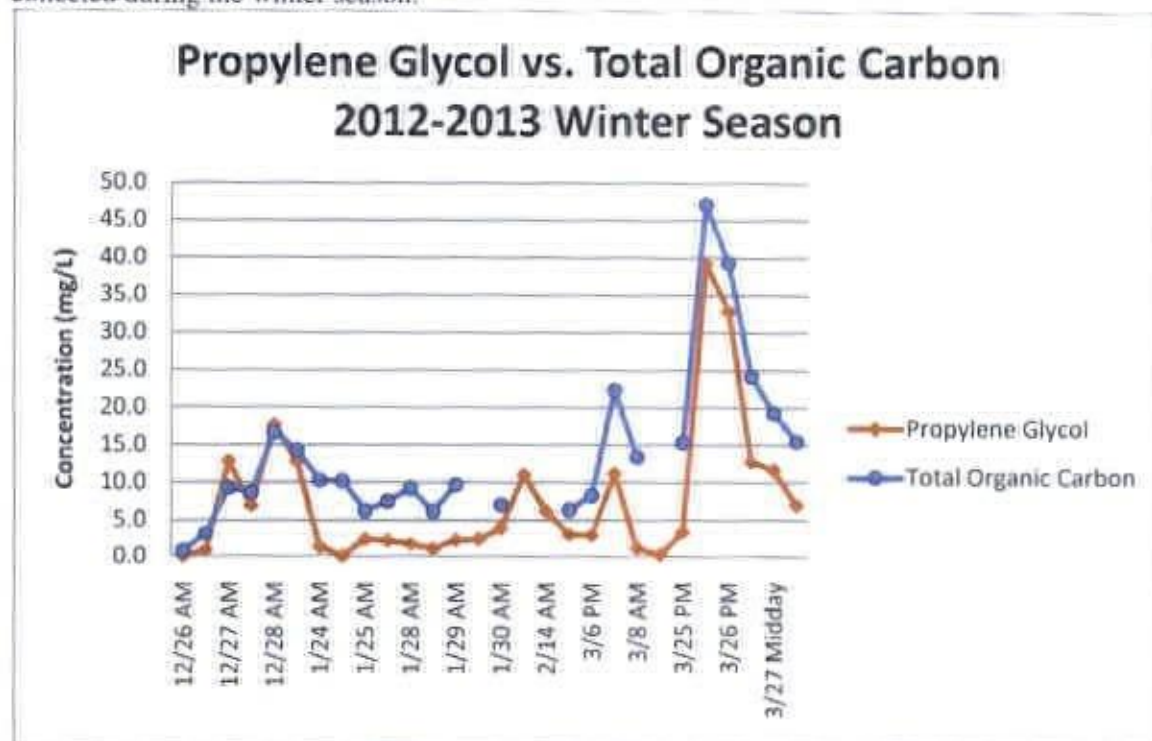
As required by the VPDES Permit, the Airports Authority began collecting data from the On-line TOC Monitor during this past season. Overall, the TOC Monitor operated within specifications throughout the winter season. The chart below shows the concentrations of propylene glycol and TOC collected during the winter season.

In March 2010, the Airports Authority installed a Total Organic Carbon (TOC) On-line Monitor at SS001 (Horsepen Lake Outfall) as required by the VPDES Permit. In September 2010, the TOC Monitor was replaced due to continuous malfunctions.

During this past season, data was collected to determine if the 1:1 ratio remained. However, this season no clear ratio was apparent. During some sampling periods, a 1:1 ratio was seen; however, other sampling periods revealed more of a 2:1 ratio for TOC to propylene glycol. The overall ratio for the 2012-2013 winter season was found to be 1:¾ correlation of TOC to propylene glycol. We will continue in the coming seasons to monitor the relationship between TOC and propylene glycol.

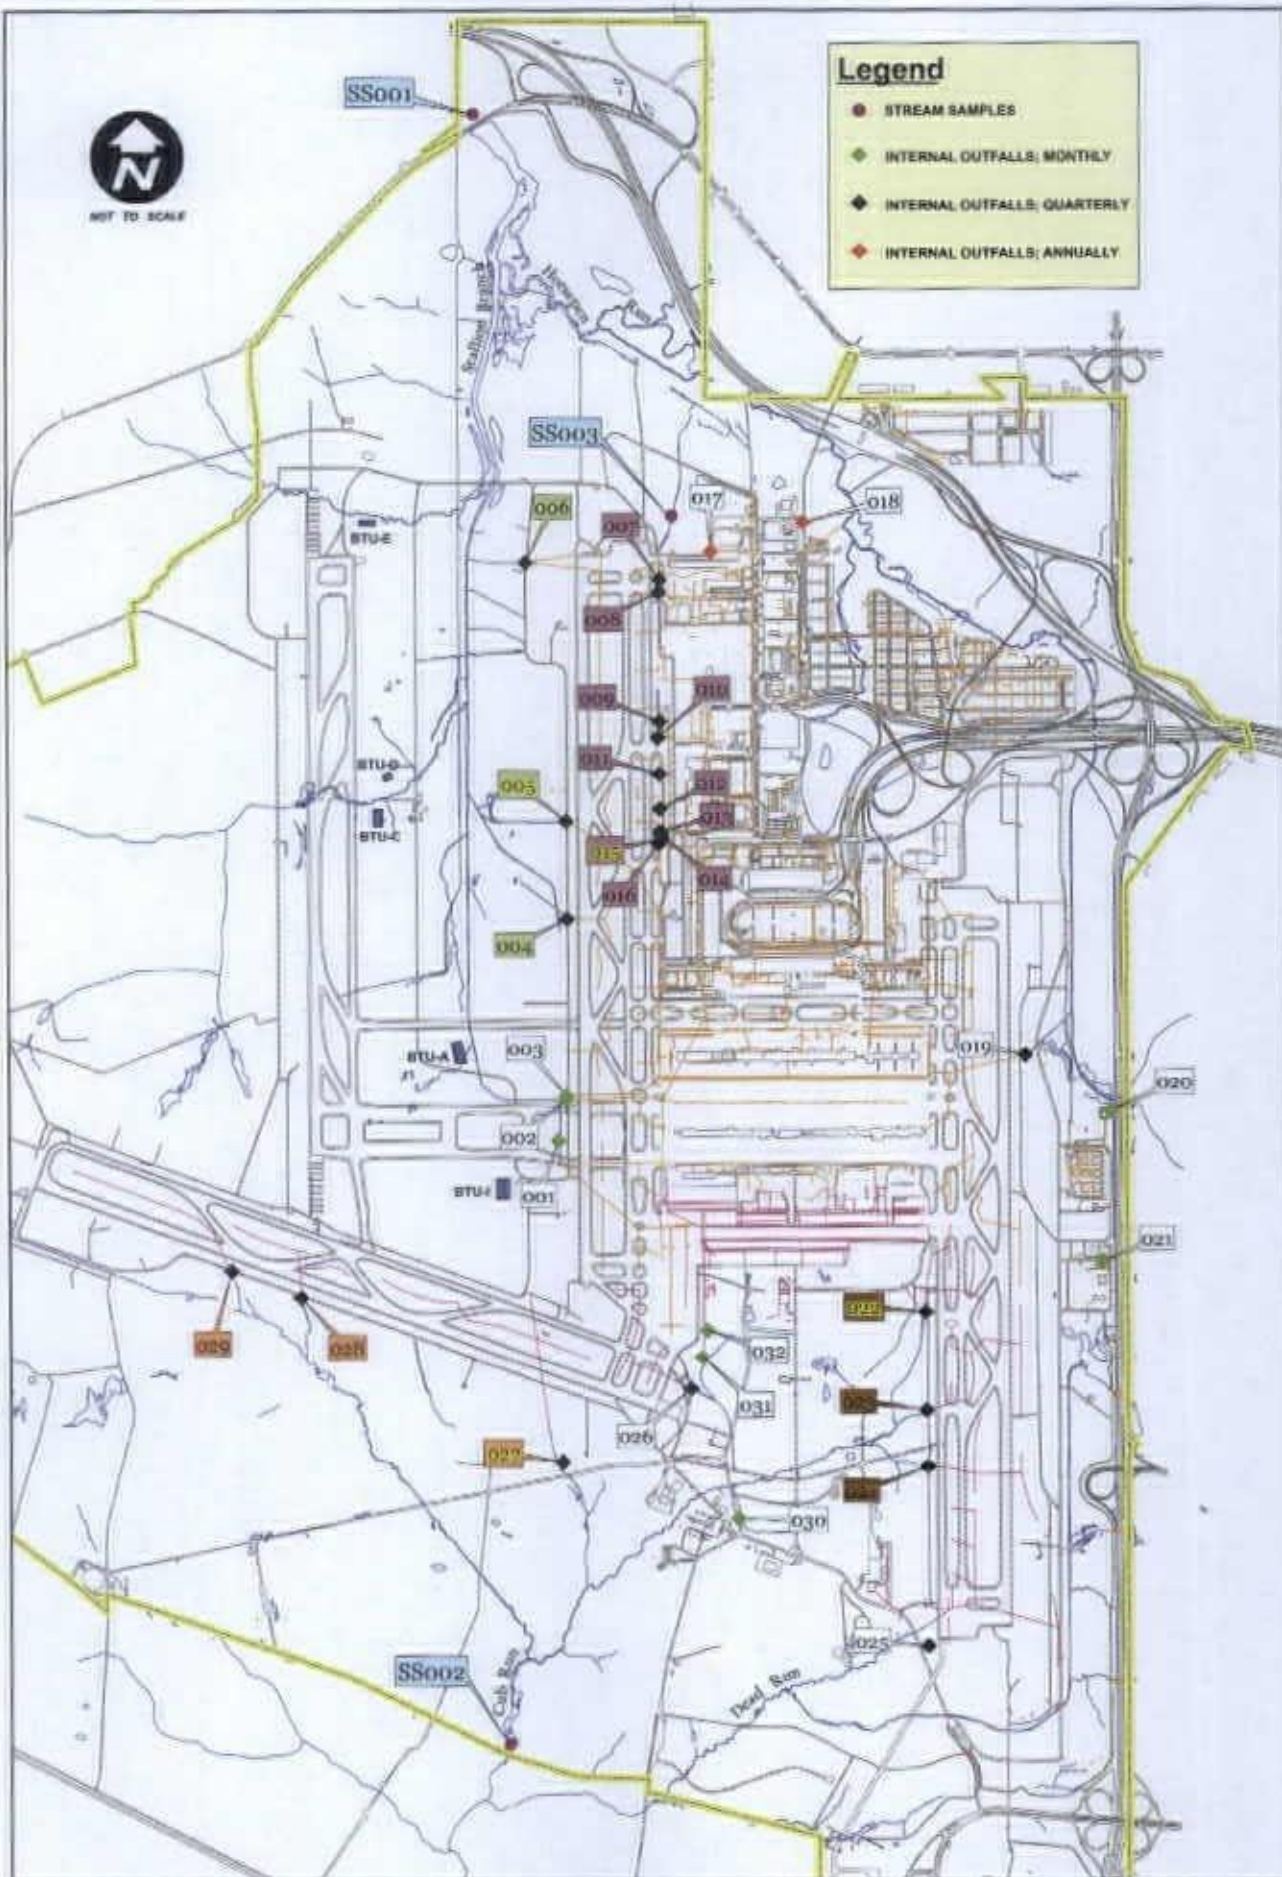
- STREAM SAMPLES
- ◆ INTERNAL OUTFALLS: MONTHLY
- ◆ INTERNAL OUTFALLS: QUARTERLY
- ◆ INTERNAL OUTFALLS: ANNUALLY

The environmental consultant prepares and submits a monthly report of the monitoring activity that includes copies of laboratory analyses, field notes, and report of visual findings. They also provide by June 1 of each year the Airports Authority a summary of annual monitoring data from May (in the previous year) through April (in the current year) for inclusion to the annual report to DEQ. The figure in Appendix C illustrates the location and monitoring frequency of each outfall.
